Fourth Primary Education Development Program (PEDP-4)

Semi-Annual Environmental Monitoring Report

Department of Public Health Engineering (DPHE)

Jan'2023 – June'2023

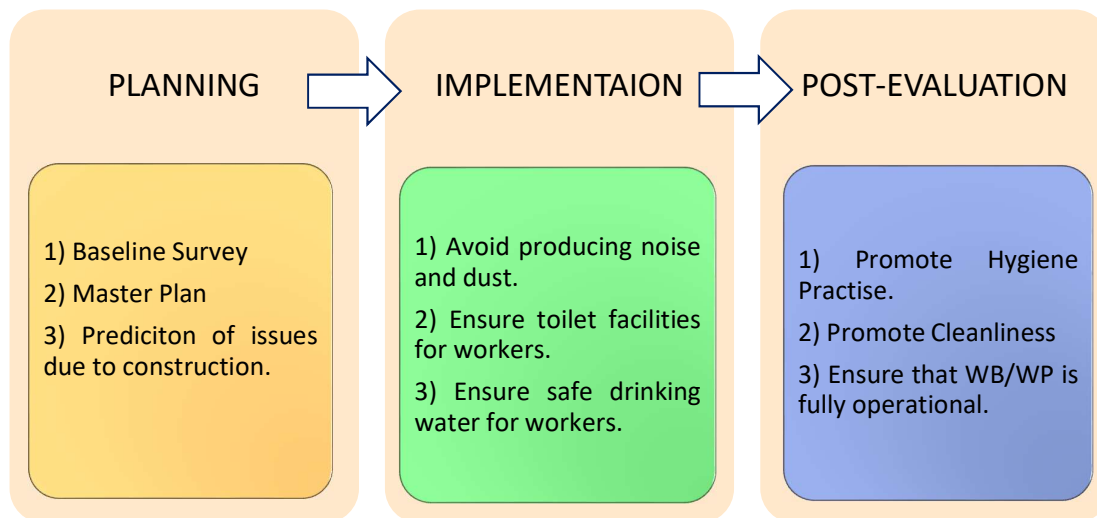
Fig. 3 Role of DPHE in environmental monitoring

an implementing agency, DPHE is involved significantly from construction till post-construction monitoring. Role of DPHE is depicted in Fig.3. It can be noted that the defect liability period for installed water points and constructed wash blocks are 02 and 01 year respectively. This implies that contractor is responsible to rectify any sort of defects within this time frame counting from the date of handover of tube well and wash block. In order to get a clear picture of ongoing and completed works, DPHE district office arranges monthly monitoring meeting with all concerned officers and staffs of that district. Executive Engineers thus address the issues of monitoring to the assistant/ sub assistant engineers monthly. Officers of concerned district along with newly appointed supervision consultant used to visit the sites frequently in order to monitor the ongoing and completed works and also focus on the environmental safeguard aspect. Visit of senior supervision consultant from Focal Point's Office and DPHE Head quarter happens frequently.

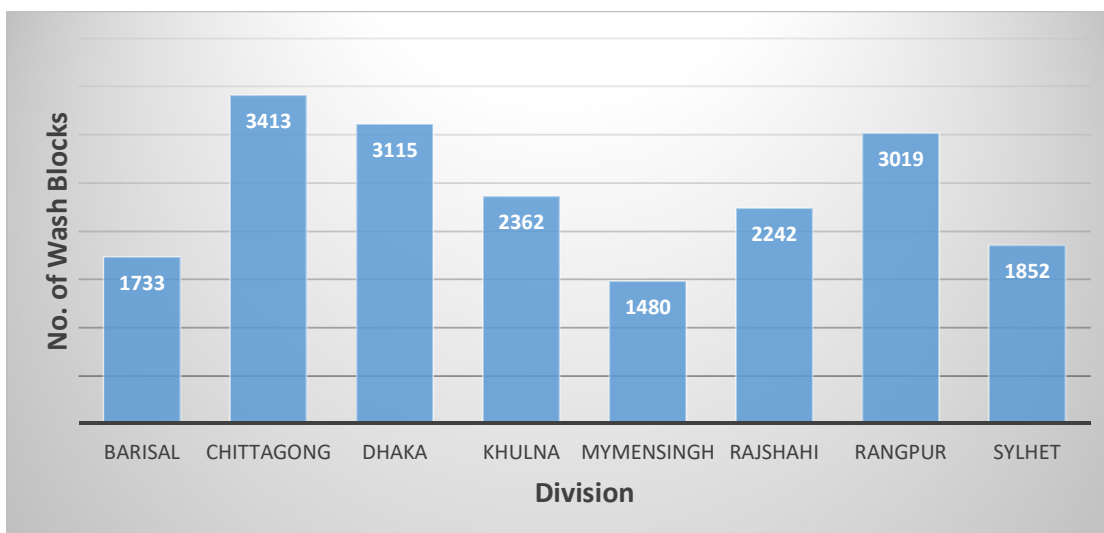
Fig. 9 Countrywide distribution of Wash Blocks

Countrywide distribution of water sources and wash blocks were analyzed and division wise categorization for water sources and wash blocks is depicted in Figs. 8 and 9 respectively. It is fact that, tube well ensures safe drinking water for the school children as well as for the teachers. Fig. 8 shows the equity in distribution of water sources. Among the total installed water points, the highest number was installed in the Chattogram division followed by Rajshahi and Sylhet division while the minimum number of water points was installed in the Mymensingh division. This is as per the need assessment criteria and the approved list issued by DPE based on approved IPG.

Wash Block is serving as a unique unit of hygiene practice for the school children as well as for teachers. Its impact on the environment is high as it helps to promote hygiene as well as a safe and clean school environment. Open defecations and urination practices decrease through the utilization of wash blocks and they confirm better health through improved washing facilities. Fig. 9 reflects the countrywide distribution of wash blocks depending on the number of districts and upazillas in each division. The maximum number of wash blocks were constructed in the Chattogram, Dhaka, Rangpur, and Khulna divisions as these divisions cover the maximum districts. The lowest number of wash blocks (1480) was constructed in the Mymensingh division as it is the smallest division of Bangladesh and thus, equity in distribution is justified.

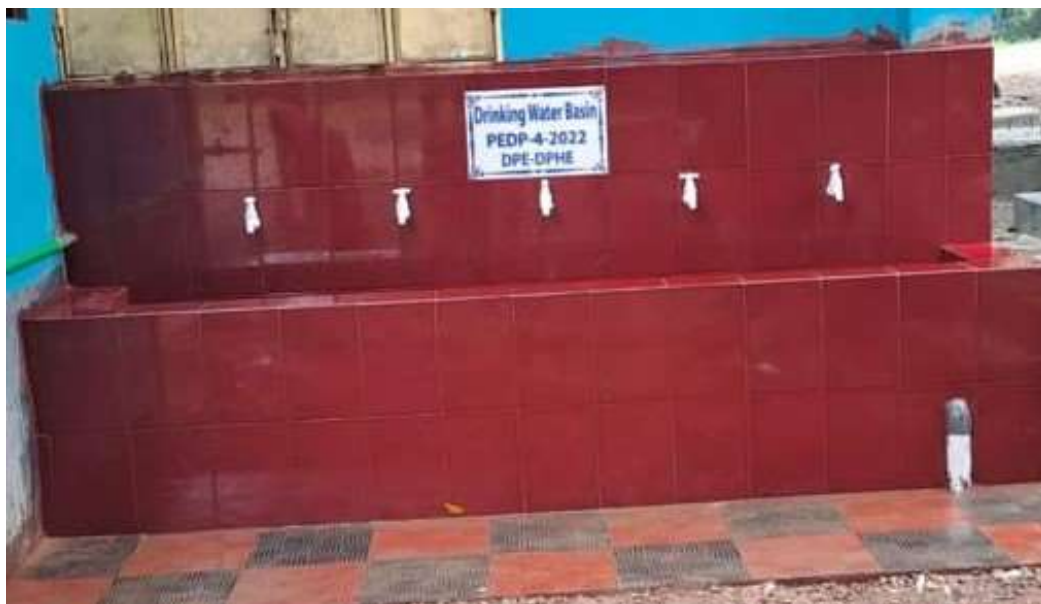
Fig. 10 Five Outlet Water Collection Basin

- 1) Pipe out used water to the existing drains (if any).
- 2) Use of 5-ring soaks well to drain out basin water where the surface drain is absent.
- 3) Construction of 5 user water collection basin having 50mm dia. PVC washout pipe. Fig. 10 Shows a newly constructed 5-outlet hand washing basin under PEDP-4.

Because, DPHE local office took the initiative in solving the drainage issue, it has been observed that the water logging problem is insignificant compared to that in PEDP-3. However, it is revealed that out of 3,608 water sources about 1.42% had the problem of water logging. The reasons observed are mainly lack of cleanliness which created blockage of drainage pipe by wastes like paper, tree leaves, mud, etc. It is hence suggested that SMC needs to look after this issue and run a regular cleanliness program in the water collection basins and drains.

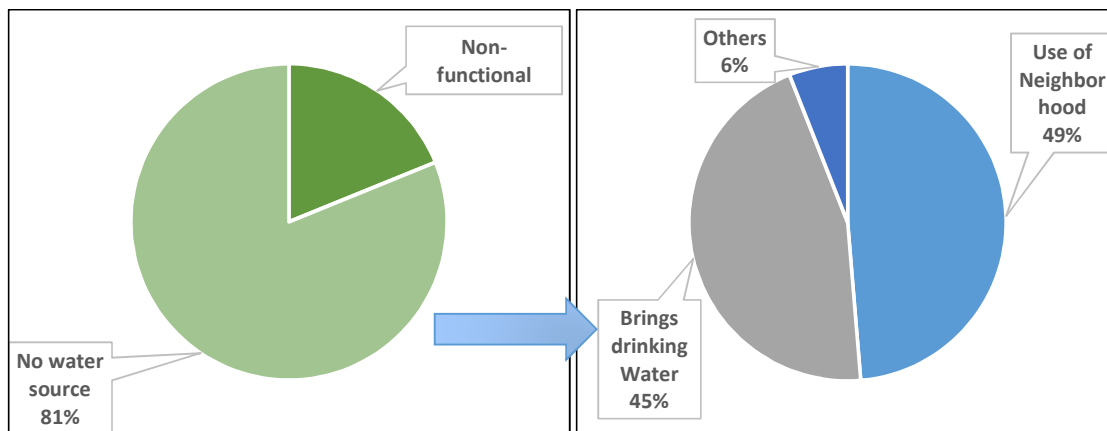
Fig. 11 Assessment of schools prior to the installation of new water sources

During preliminary survey it was found that, out of 3,608 schools 81% did not have their own active water option. 49% of them used the facility of their neighborhood. Though 19% schools have their own tube wells, yet those tube wells were found as non-functional or did not provide sufficient water during dry season. From this information during the preliminary screening, DPHE took initiative in solving the above problem by installing new tube wells (approved list of which schools were duly provided by DPE) with submersible pump but at different depth as appropriate to the site geology.

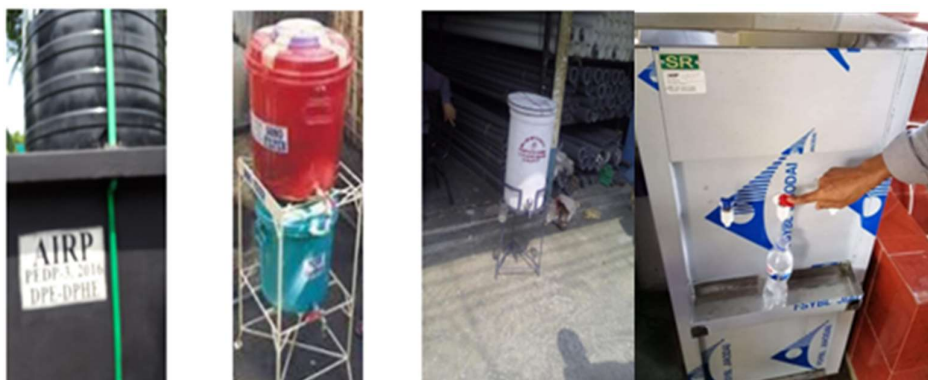
Fig. 13 Different Suggested Improved Filtration Technologies

In cases where arsenic/iron/chloride is found beyond allowable BDS standard in installed water sources, DPHE adopts other approved alternate water options. DPHE goes for options like deep tube well of greater depth, ring well, pond sand filter, rain water harvesting, Reverse Osmosis Filter, AIRP, Small box type AIRP etc. whichever is feasible. In some cases, if all the options in hand fails, i.e., boring in greater depth becomes impossible, arsenic is found even in deep tube well and none other option is feasible, DPHE has started implementing ‘SONO Filter’ as well. DPHE upazilla offices will arrange and install the said filter in those water sources whichever is feasible, convenient, and justified. In addition, water from those sources will be further tested and declared safe if found well below the BDS standard of drinking water. Fig. 13 shows some of the suggested filtration technologies.

It is fact that, in the reporting tenure a total of 28 water sources were found to have water quality concerns with excessive arsenic. For all the said 28 water points, Reverse Osmosis (RO) were installed and filtered water was tested in DPHE zonal Laboratories. The water sources were handed over to the respective schools once the water quality results were found satisfactory. Water quality test results are summarized in Table 1 of Appendix 6.

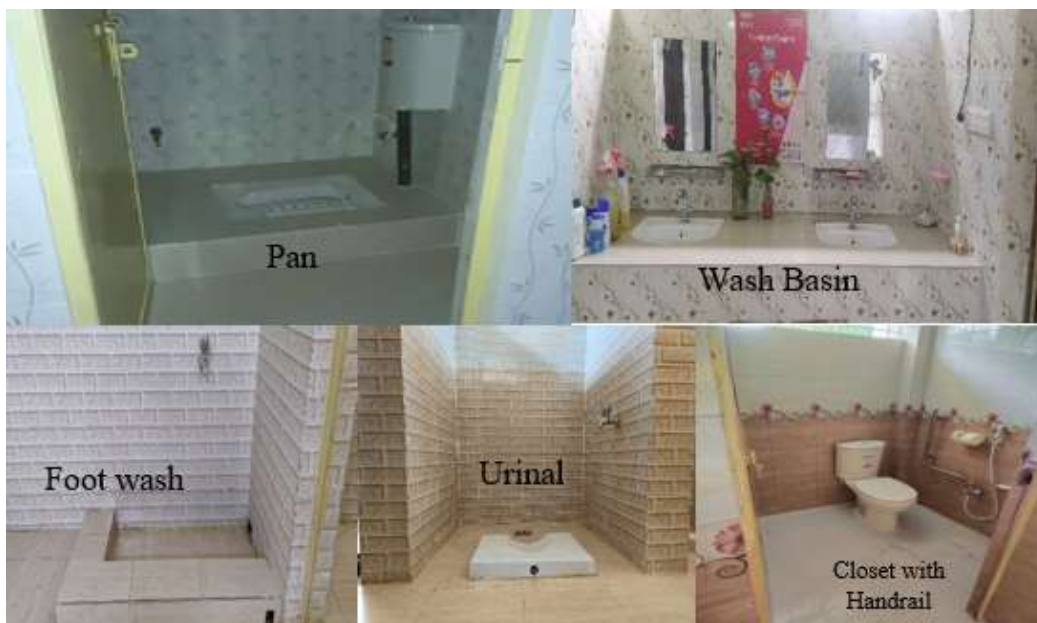
Fig. 14 Modern Interior of Wash Blocks

Working with the motto of 'clean hand, safe hand' DPHE confirmed the installation of tube wells with running water supply by the provision of submersible pumps in all the above-mentioned schools during the reporting tenure. The construction of a wash basin for hand washing (Fig.9) ensured total hand washing facilities in the school. Due to the global pandemic situation, although regular hygiene promotion activities could not be conducted yet monthly coordination meeting with DPE officials, TEO, ATEO, and Primary School Headmasters is an indication of the intensity of preparation for hygiene activities.
