Fourth Primary Education Development Program (PEDP-4)

Semi-Annual Environmental Monitoring Report DEPARTMENT OF PUBLIC HEALTH ENGINEERING

[A report on WASH facilities and its environmental impact under PEDP-4]

January 2021 – May 2021

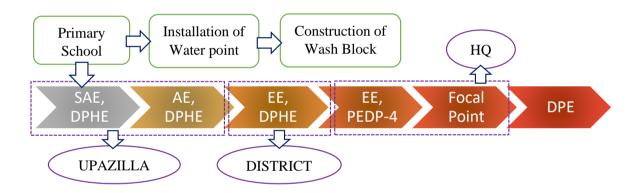
Fig. 1 Method of environmental safeguard screening

Data for environmental safeguard screening during the installation of water sources and maintenance of Wash Blocks have been collected from the schools through DPHE official sources using the structured format (copy enclosed in Appendix-1 of this report). Data collected from grass root level have been entered into 'Master Environmental Survey Outcome' Spreadsheet by MIS UNIT and kept structured for database and reporting. A flow diagram of the screening method is depicted in Fig. 1.

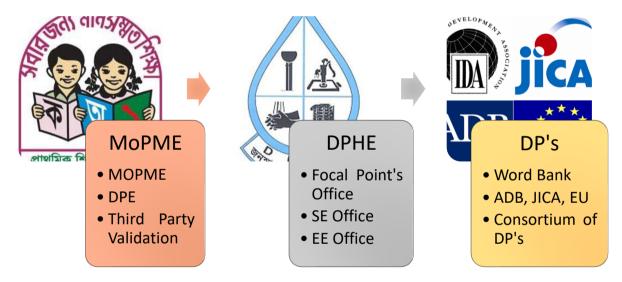
Fig. 2 Monitoring scheme in PEDP-4

The subcomponents of PEDP-4 especially the infrastructural implementation is comprehensively monitored by several parties from commencement to operational phase. Fig.2 shows the monitoring scheme in PEDP-4 operated by different agencies. Being an implementing agency, DPHE is involved significantly from construction till post-construction monitoring. Role of DPHE is depicted in Fig.3. It can be noted that the defect liability period for installed water points and constructed wash blocks are 02 and 01 year respectively. This implies that contractor is responsible to rectify any sort of defects within this time frame counting from the date of handover of tube well and wash block. In order to get a clear picture of ongoing and completed works, DPHE district office arranges monthly monitoring meeting with all concerned officers and staffs of that district. Executive Engineers thus address the issues of monitoring to the assistant/ sub assistant engineers monthly. Officers of concerned district used to visit the site frequently in order to monitor the ongoing and completed works and also focus on

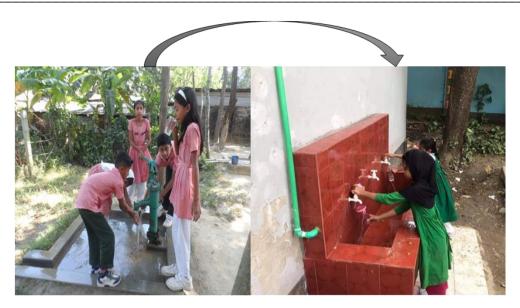
Fig. 6 Improved water sources by TSP from hand tube well

Fig. 6 shows the previous and improved water supply facilities in primary schools under PEDP-4.

Installation of tube well with submersible pump added values to its user especially young user which eventually <u>increases the easy access to safe drinking water result in health benefit</u> as well as diminishes water logging and drainage problem.

In order to mitigate the concerns and to make the water sources more popular and user friendly, DPHE started installing Tube well with Submersible Pump (TSP) in all the primary schools under PEDP-4. This option has special features such as-

- > Running water supply with storage facility.
- Multiple users can access at the same time.
- > Promote hygiene practice through safe hand washing.

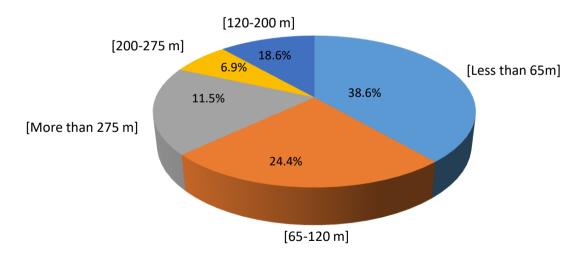
Fig. 7 Distribution of water points based on depth

DPHE installed tube wells of varying depth in different primary schools of Bangladesh considering the geological formation of respective district. Although the depth of tube well depends on the suitable water layer, all the tube wells installed in the reporting tenure can be broadly categorized into five distinct types based on the depth of tube well. Fig. 7 depicts the classification of tube wells based on depth. It is clear that 18.4% tube wells were installed at a greater depth of 200m or more. Number of tube wells were in the range of 81.6% where the depth is less or equal to 200m.

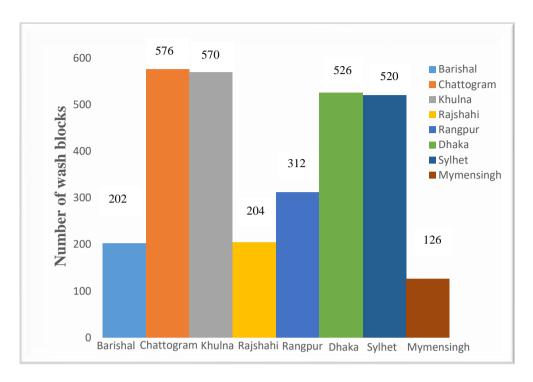
Fig. 8. Countrywide Wash Block distribution

Countrywide distribution of Wash Blocks and Tube wells were surveyed and categorized division wise. Fig. 8. reflects the countrywide distribution of wash blocks depending on the number of districts and upazillas in each division. The maximum number of wash blocks were constructed in the Chattogram,

Khulna, Dhaka and Sylhet division as these divisions cover maximum districts. The lowest number of wash blocks (126) were constructed in Mymensingh division as it is the smallest division of Bangladesh and thus, equity in distribution is justified. Fig. 9 also depicts the equity in distribution of water sources. Among the 915 water points, the highest number was installed in the Chattogram division and least proportion was in the Mymensingh division. This is also justified as per need assessment criteria based on approved IPG.

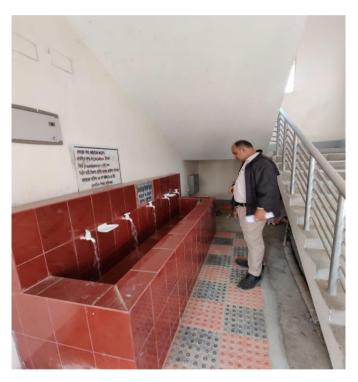
Fig. 11 Tube Well with Submersible Pump having 05 running water outlets

- 1) Pipe out used water to the existing drains.
- 2) Construction of 5 user water collection basin having 50mm dia. PVC washout pipe. Fig. 11. shows a newly constructed 5 outlet hand washing basins under PEDP-4.
- 3) Use of 8 ring soaks well to drain out basin water where surface drain is absent.

As because, DPHE local office took initiative in solving the drainage issue, it has been observed that, the water logging problem is insignificant compared to that in PEDP-3. However, it is revealed that out of 915 water sources about 1% had the problem of water logging. The reasons observed are mainly because of current COVID-19 situation schools are closed and hence the lack of cleanliness program was observed which created blockage of drainage pipe by wastes like paper, tree leaves, mud etc. It is hence suggested that, SMC needs to look after this issue and run regular cleanliness program in the water collection basin and drains.

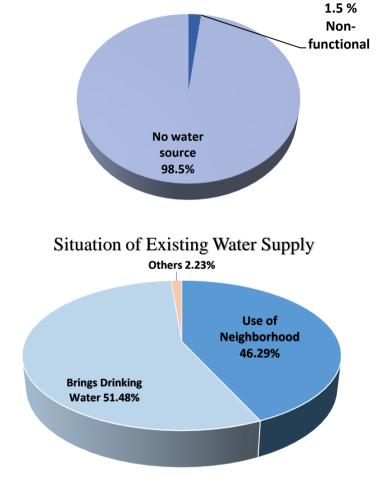
Fig. 12 Assessment of schools where new water points were installed

During preliminary survey it was found that (Fig.12), out of 915 schools 98.5% did not have their own water option. 46.29% of them used the facility of their neighborhood. Though 1.5% schools have their own tube wells, yet those tube wells were found as non-functional or did not provide sufficient water during dry season. From the lessons learnt during the environmental screening in PEDP-3, DPHE took initiative in solving the above problem by installing new tube wells with submersible pump but at different depth as appropriate to the site geology.

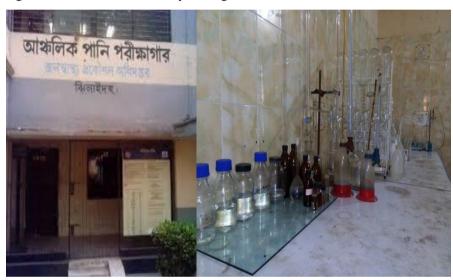
Fig. 13 DPHE Zonal Laboratory setup for water testing

During installation of water points, suitable water layers are generally selected based on the DPHE's experience and geographic location. After installation of new water points in the said 915 schools, laboratory tests were conducted to identify potential hazards of Arsenic, Iron and Chloride in water. The tests were done by the laboratory circle of DPHE and the reports are stored in the DPHE MIS database. Figure below shows laboratory testing facilities of DPHE.

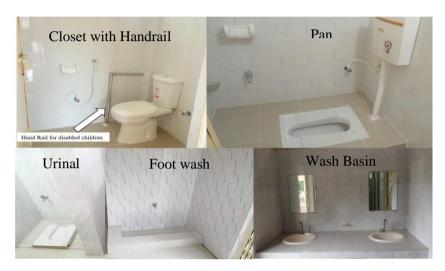
Fig. 16 Modern Interior of Wash Blocks

Prior to the installation of water sources, hand washing of students before and after meal especially mid-day meal and after using toilet was a matter of concern. As a result, students were more susceptible to diseases which triggered the absence of students from school. Besides these, newly constructed wash blocks with modern interior facility will surely create enthusiasm among children for the best utilization of wash blocks. A glimpse of wash block interior is shown in Fig 16.

Working with the moto of 'clean hand, safe hand' DPHE confirmed the installation of tube wells with running water supply by provision of submersible pump in all the above-mentioned schools during the reporting tenure. Construction of wash basin for drinking as well as hand washing (Fig.13) ensured total hand washing facilities in the school. Due to the global pandemic situation, although regular hygiene promotion activities could not be conducted yet monthly coordination meeting with DPE officials, TEO, ATEO and Primary School Headmasters is the indication of intensity of preparation for hygiene activities.

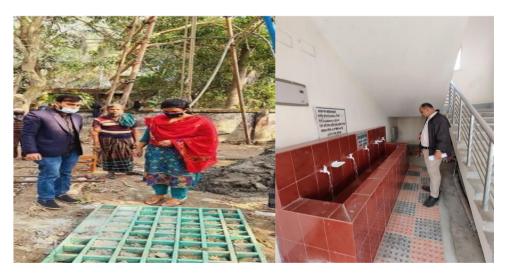
Fig. 19 Monitoring of Tube well installation in presence of Executive engineer, DPHE

During post evaluation phase in the findings were found satisfactory and the water source was found functional.

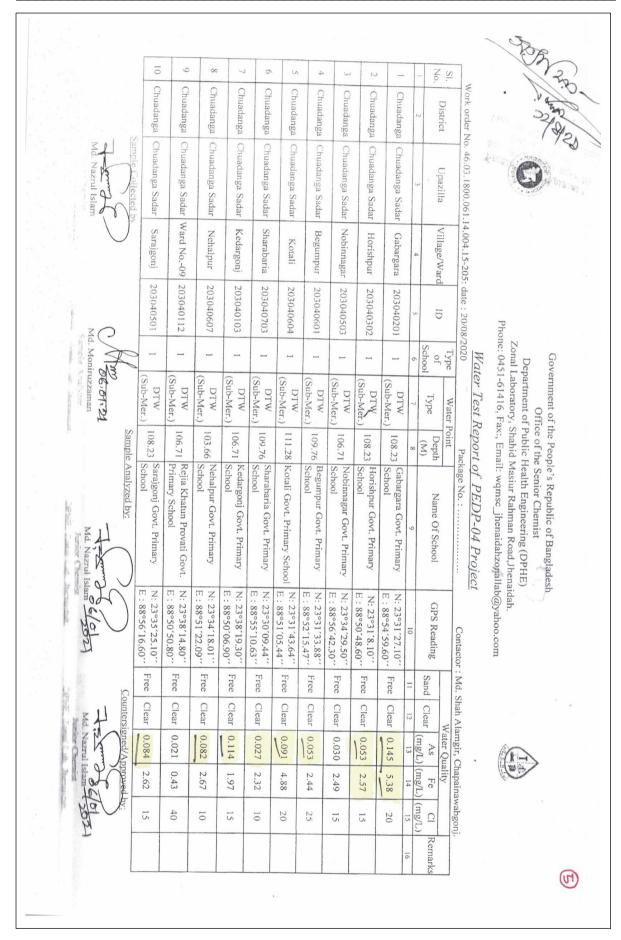
13.8 16.3 0.4 0.7	0.5 0.5 1.4 1.57 1.57 0.1	16 21 10 38 86 10 10 30 10 30 10 30 10 30 10 10 10 10 10 10 10 10 10 10 10 10 10	Lab Test Data
-				5 6

Water Foint Park			T							-				0	É	20
Package No. : Contactor : Md. Shah Alamgir, Chapainawabgonj. Package No. : Water Point Water Quality Water Quality Package No. : Water Quality Water Point Name Of School GPS Reading Sand Clear Quality GPS Reading Sand Clear Quality GPS Primary School Research Sand GPS Primary School Research Sand GPS Primary School Research Sand Sand GPS Primary School Research Sand Sand GPS Primary School Research Sand Sand GPS Primary School Research Sand Sand GPS Primary School Research Sand			-	-	-	16	15	4	22	12	11	-	Zo.	SI.] <u>.</u>	Lab
Package No. : Contactor : Md. Shah Alamgir, Chapainawabgonj. Package No. : Water Point Water Point Water Quality Water Quality Package No. : Water Point Water Quality Water Quality Package No. : Water Quality Water Quality Name Of School GPS Reading Sand Clear Color As Fed Cil Package	DPH	_	Chuadanga	Chuadanga	Chuadanga	Chuadanga	Chuadanga	Chuadanga	Chuadanga	Chuadanga	Chuadanga	2	Z Z Z Z Z Z Z Z Z Z Z Z Z Z Z Z Z Z Z	District	Vork order N	2/8/2
