Fourth Primary Education Development Program (PEDP-4)

Semi-Annual Environmental Monitoring Report

DEPARTMENT OF PUBLIC HEALTH ENGINEERING

Jan 2022 - June 2022

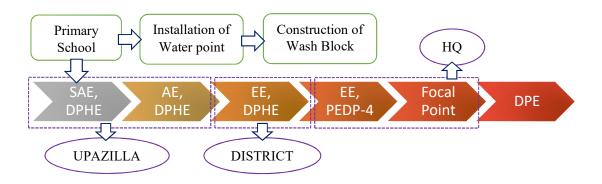
Fig. 1 Method of environmental safeguard screening

Data for environmental safeguard screening during the installation of water sources and maintenance of Wash Blocks have been collected from the schools through DPHE official sources using the structured format (copy enclosed in Appendix-1 of this report). Data collected from grass root level have been entered into 'Master Environmental Survey Outcome' Spreadsheet by MIS UNIT and kept structured for database and reporting. A flow diagram of the screening method is depicted in Fig. 1.

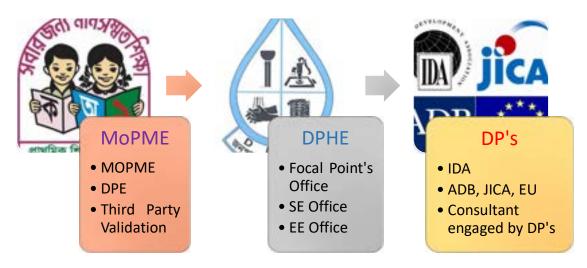
Fig. 2 Monitoring scheme in PEDP-4

The subcomponents (sub component 2.3 and 2.4) of PEDP-4 especially the infrastructural implementation is comprehensively monitored by several parties from commencement to operational phase. Fig.2 shows the monitoring scheme in PEDP-4 operated by different agencies. Being an implementing agency, DPHE is involved significantly from construction till post-construction monitoring. Role of DPHE is depicted in Fig.3. It can be noted that the defect liability period for installed water points and constructed wash blocks are 02 and 01 year respectively. This implies that contractor is responsible to rectify any sort of defects within this time frame counting from the date of handover of tube well and wash block. In order to get a clear picture of ongoing and completed works, DPHE district office arranges monthly monitoring meeting with all concerned officers and staffs of that district. Executive Engineers thus address the issues of monitoring to the assistant/ sub assistant engineers monthly. Officers of concerned district used to visit the site frequently in order to monitor

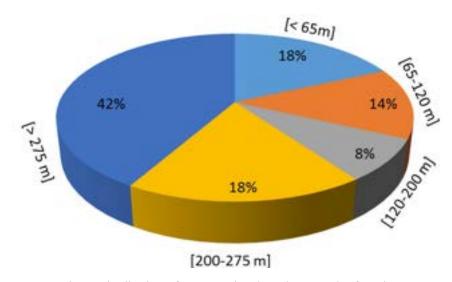
Fig. 7 Distribution of Water Points based on Depth of Boring

DPHE installed tube wells of varying depth in different primary schools of Bangladesh considering the geological formation of respective district. Although the depth of tube well depends on the suitable water layer, all the tube wells installed in the reporting tenure can be broadly categorized into five distinct types based on the depth of tube well. Fig. 7 depicts the classification of tube wells based on depth. As shown in Table 2, a total of 2,500 nos. of water points were installed under PEDP4 during the reporting tenure. It is clear from Fig. 7 that 42% tube wells were installed at a greater depth of 275m or more which is considered as deep tube well. Around 18% tube wells were installed in shallow depth (<65m). Tube wells installed in between 65m to 275m are also deep tube wells and this percentage is second highest (40%) amongst all the installed water points.

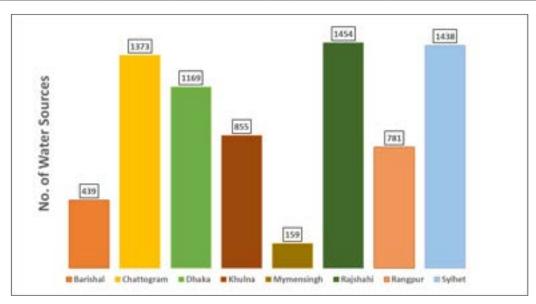
Fig. 8 Countrywide distribution of water points

Countrywide distribution of tube wells and wash blocks were analyzed and division wise categorization for water source and wash block is depicted in Figs. 8 and 9 respectively. Fig. 8 depicts the equity in distribution of water sources. Among the total installed water points, the highest number was installed in Rajshahi division followed by Sylhet and Chattogram division while the minimum number of water points was installed in Mymensingh division. This is as per need assessment criteria and approved list issued by DPE based on approved IPG.

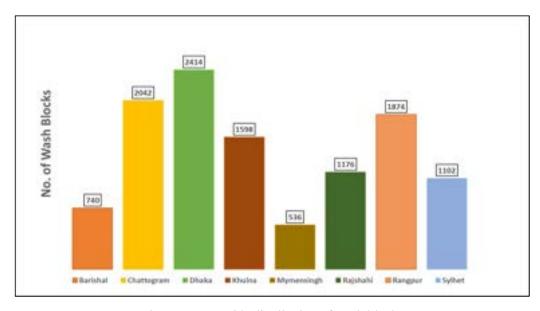
Fig. 9 Countrywide distribution of wash blocks

Fig. 9 reflects the countrywide distribution of wash blocks depending on the number of districts and upazillas in each division. The maximum number of wash blocks were constructed in the Dhaka, Chattogram, Rangpur, Khulna division as these divisions cover maximum districts. The lowest number of wash blocks (536) was constructed in Mymensingh division as it is the smallest division of Bangladesh and thus, equity in distribution is justified.

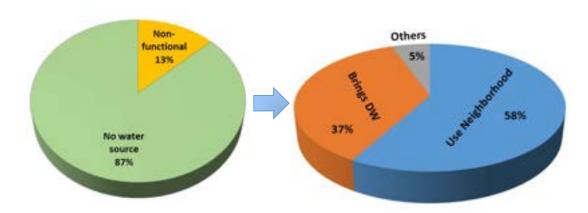
Fig. 10 Assessment of schools where new water points were installed

During preliminary survey it was found that, out of 2,500 schools 87% did not have their own active water option. 58% of them used the facility of their neighborhood. Though 13% schools have their own tube wells, yet those tube wells were found as non-functional or did not provide sufficient water during dry season. From the lessons learnt during the environmental screening in PEDP-3, DPHE took initiative in solving the above problem by installing new tube wells with submersible pump but at different depth as appropriate to the site geology.

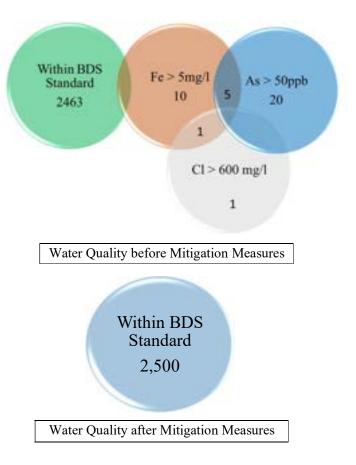
Fig. 11 Water Quality test result at a glance

During installation of water points, suitable water layers are generally selected based on DPHE's experience and geographic location. After installation of new water points in the said 2,500 schools, laboratory tests were conducted to identify potential hazards of Arsenic, Iron and Chloride in water. The tests were done by the laboratory circle of DPHE and the reports are stored in the DPHE MIS database. From the screening of 2,500 tube wells, it was found that 37 of them had the concern of excess arsenic (As) and/or, Iron (Fe) beyond the Bangladesh standard (arsenic, iron and chloride content below 50ppb, 5mg/l and 600mg/l respectively) of safe drinking water. For the rest of the cases arsenic, iron and chloride content were found satisfactory during laboratory tests.

Water Quality report of those 37 unacceptable water sources and suggested alternative option along with retest result is summarized in Table 4 of Appendix-7. Fig. 12 shows the diagrammatic presentation of water quality test results. In addition, ample field tests were conducted in those

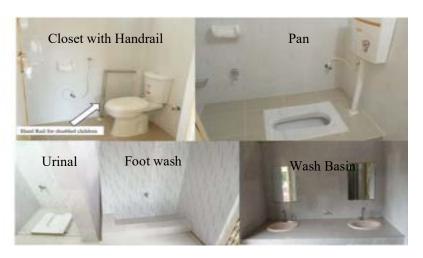
Fig. 13 Modern Interior of Wash Blocks

Working with the moto of 'clean hand, safe hand' DPHE confirmed the installation of tube wells with running water supply by provision of submersible pump in all the above-mentioned schools during the reporting tenure. Construction of wash basin for hand washing (Fig.10) ensured total hand washing facilities in the school. Due to the global pandemic situation, although regular hygiene promotion activities could not be conducted yet monthly coordination meeting with DPE officials, TEO, ATEO and Primary School Headmasters is the indication of intensity of preparation for hygiene activities.
