June, 2020 Biannual Report

Environmental Screening Report

DEPARTMENT OF PUBLIC HEALTH ENGINEERING

[A report on WASH facilities and its environmental impact under PEDP-4]

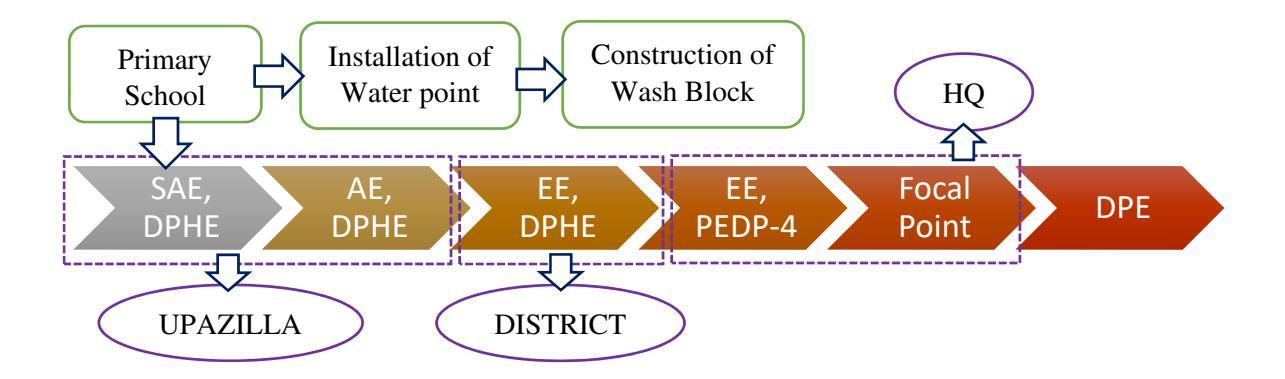
Data for environmental safeguard screening during the installation of water sources and maintenance of Wash Blocks have been collected from the schools through DPHE official sources using the structured format (copy enclosed in Appendix-1 of this report). Data collected from grass root level have been entered into 'Master Environmental Survey Outcome' Spreadsheet by MIS UNIT and kept structured for database and reporting. A flow diagram of the screening method is depicted in Fig. 1.

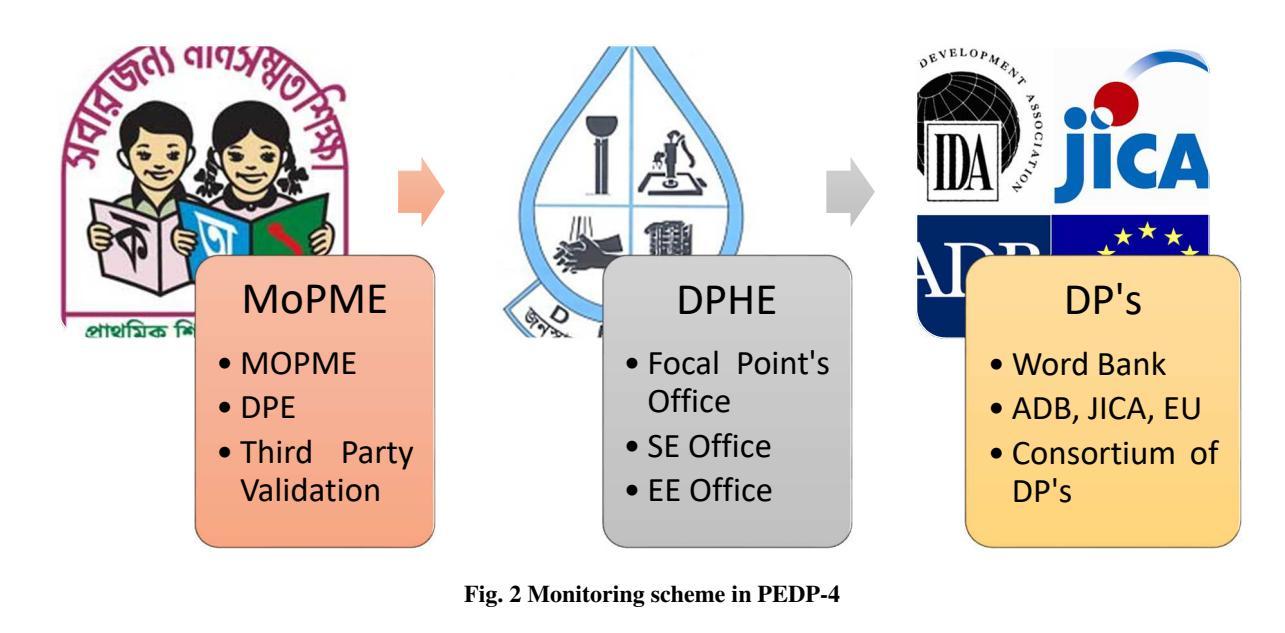
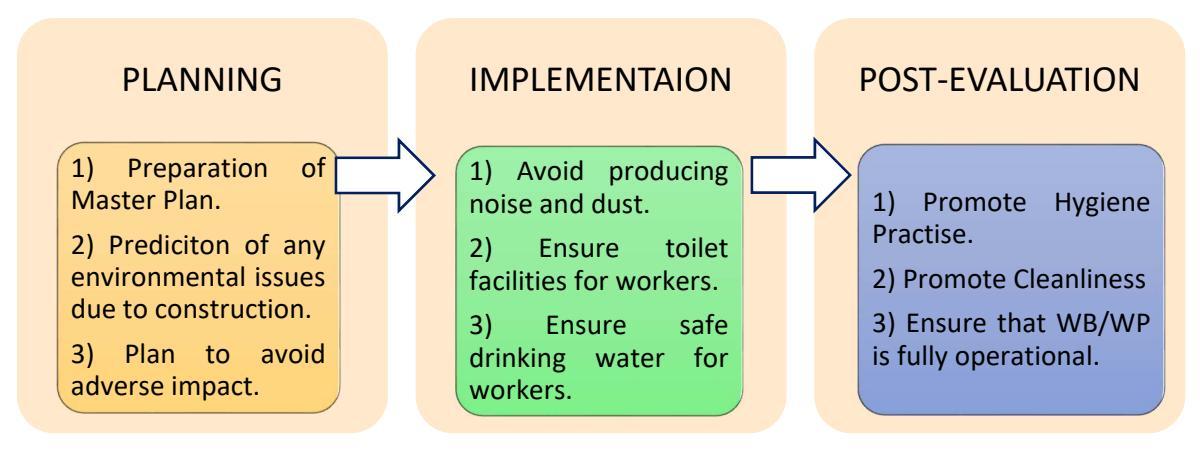
Fig. 3 Role of DPHE in environmental monitoring

The subcomponents of PEDP-4 especially the infrastructural implementation are comprehensively monitored by several parties from commencement to operation. Fig.2 shows the monitoring scheme in PEDP-4 operated by different agencies. Being an implementing agency, DPHE is involved significantly from construction till post-construction monitoring. Role of DPHE is depicted in Fig.3. It can be noted that the defect liability period for installed water points and constructed wash blocks are 02 and 01 year respectively. This implies that contractor is responsible to rectify any sort of defects within this time frame counting from the date of handover of tube well and wash block. In order get a clear picture of ongoing and completed works, DPHE district office arranges monthly monitoring meeting with all concerned officers and staffs of that district. Executive Engineers thus address the issues of monitoring to the assistant/ sub assistant engineers monthly. Officers of concerned district used to visit the site frequently in order to monitor the ongoing and completed works and also focus on the environmental safeguard aspect. Visit from Focal Point's Office and DPHE Head quarter happens frequently.

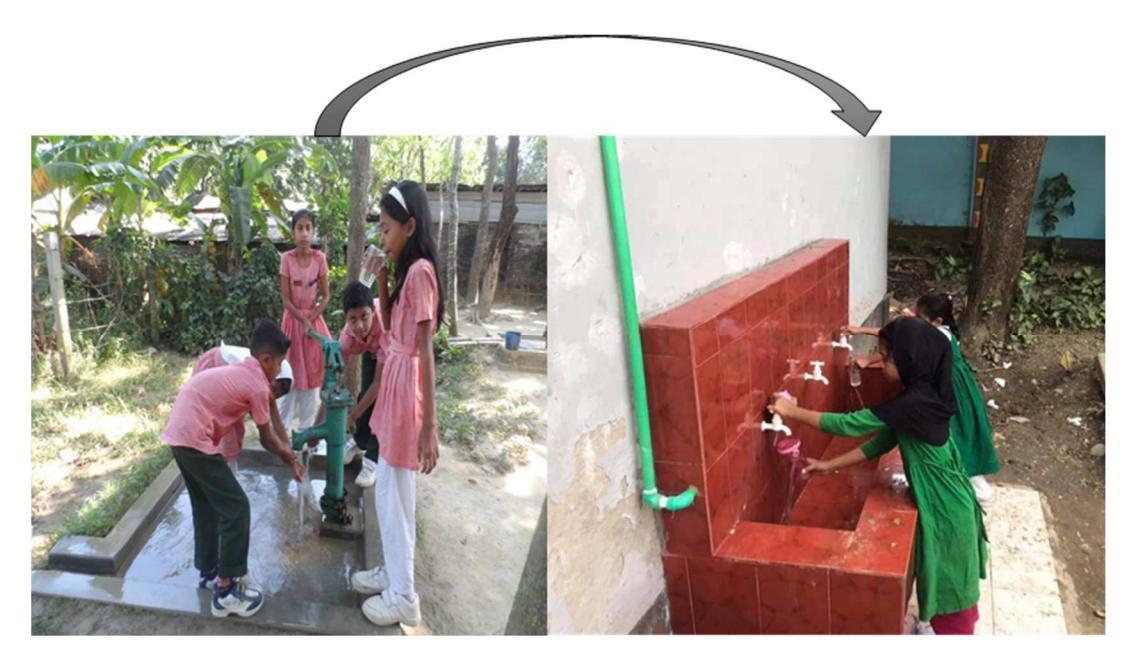
Fig. 5 Improved water sources by TSP from hand tube well

Fig. 5 shows the previous and improved water supply facilities in primary schools under PEDP-4.

Installation of tube well with submersible pump added values to its user especially young user which eventually *increases the easy access to safe drinking water result in health benefit* as well as diminishes water logging and drainage problem.

In order to mitigate the concerns and to make the water sources more popular and user friendly, DPHE started installing Tube well with Submersible Pump (TSP) in all the primary schools under PEDP-4. This option has special features such as-

- ▶ Running water supply with storage facility.
- > Multiple user can access at the same time.
- > Promote hygiene practice through safe hand washing.

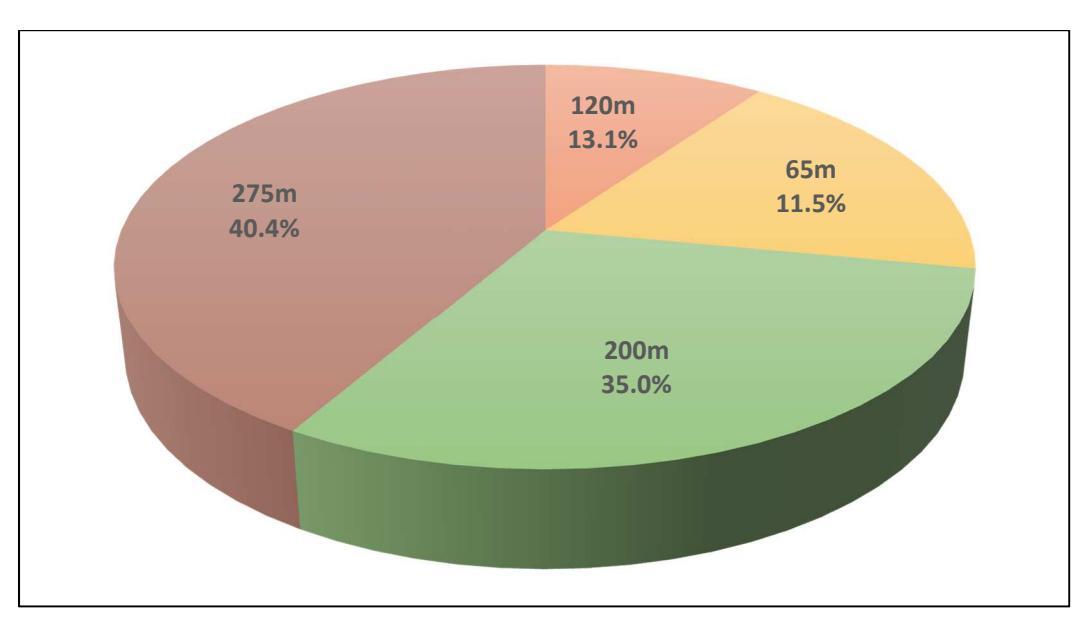
Fig. 6 Distribution of water points based on depth

DPHE installed tube wells of varying depth in different primary schools of Bangladesh considering the geological formation of respective district. Although the depth of tube well is depended on the suitable water layer, all the tube wells installed in the reporting tenure can be broadly categorized into four distinct types based on the depth of tube well. Fig. 6 depicts the classification of tube wells based on depth. It is clear that 75.4% tube wells were installed at a greater depth of more than 200m. Number of shallow tube wells were in the range of 11.5% where the depth is less or equal to 65m.

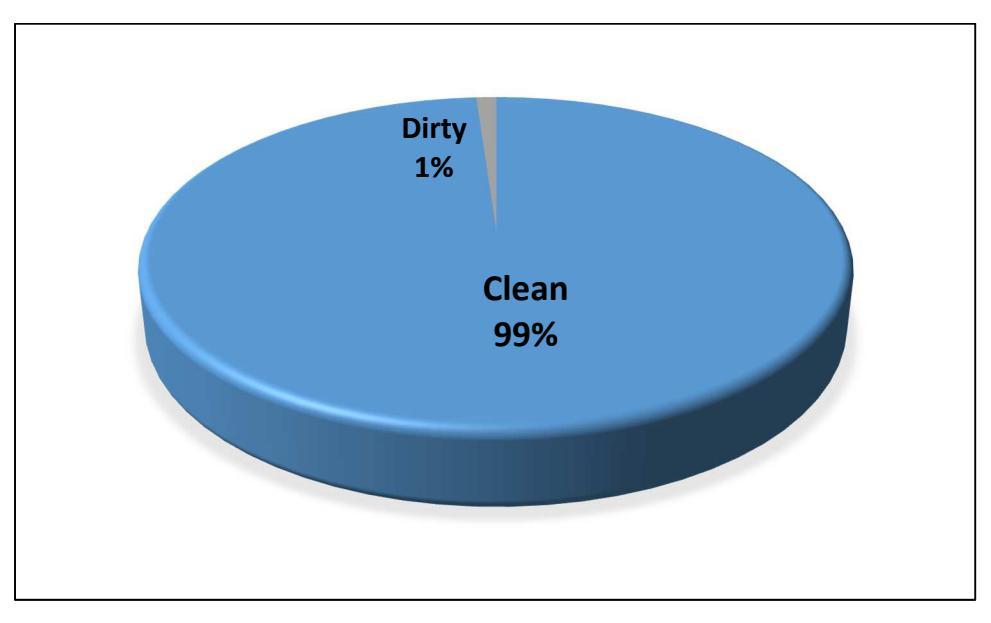
Fig. 7 Environment of water supply facility

In case of water points 'Clean Environment' refers to the surrounding of the installed water option. If the surrounding environment is not dirty and/or not covered with algae then it would be referred to as 'Clean'. Post installation monitoring of all 183 water points have been conducted. Clean environment was found in 181 water points which is 98.9% of the total water points as depicted in Fig. 7. Causes of dirty environment of water supply facility were blocked drainage due to waste dumping near the outlet. It can be noted that due to the provision of basin type water points, water logging and or other problems related to dirty environment have been dramatically reduced than that observed during the environmental screening of other types of tube well installed in PEDP-3 program.

During the monitoring phase, mitigation measures were suggested to the concerned school such as cleaning of basin, removal of leaves and other utensils that causes blockage of the drains etc. Because of taking mitigation measures, caretakers' training and routine maintenance during monitoring phase, environment of water supply facility improves to 100% from 98.9%.

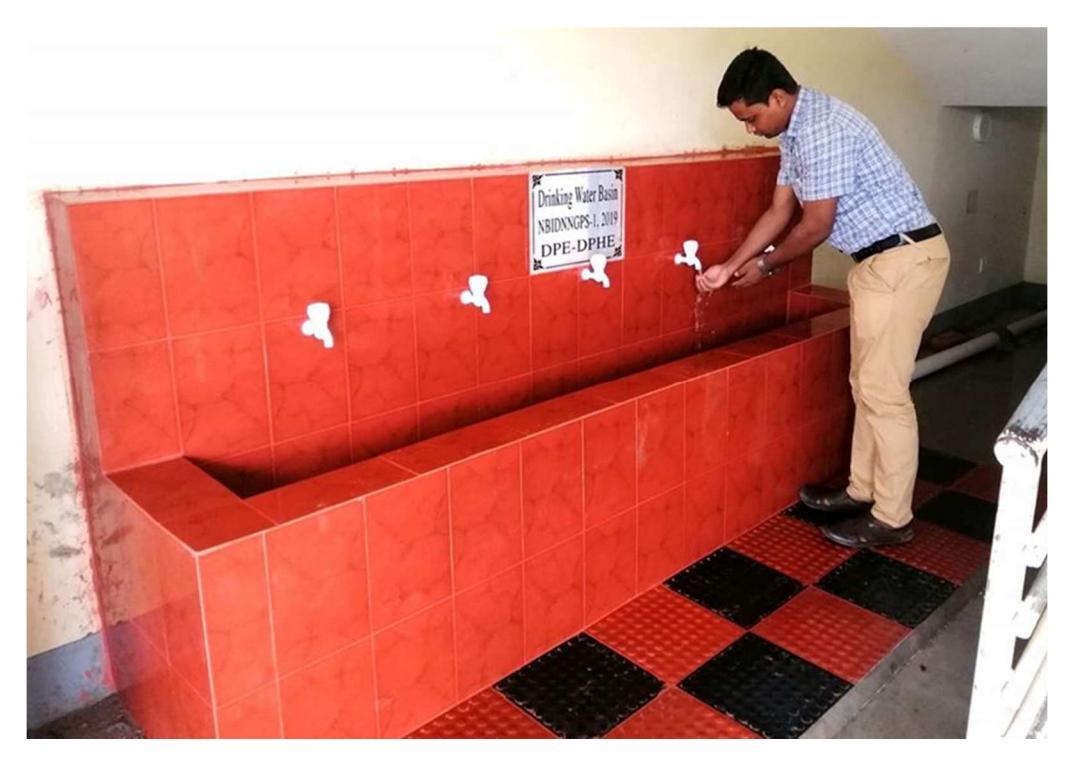
Fig. 8 Hand washing basin with TSP

- 1) Pipe out used water to the existing drains.
- 2) Construction of 5 user water collection basin having 50mm dia. PVC washout pipe. Fig. 8 shows a newly constructed 5 outlet hand washing basin under PEDP-4.
- 3) Use of 8 ring soak well to drain out basin water where surface drain is absent.

As because, DPHE local office took initiative in solving the drainage issue, it has been observed that, the water logging problem is insignificant compared to that in PEDP-3. However, it is revealed that out of 183 water sources only 1 (<1%) had the problem of water logging. The reasons observed are mainly blockage of drainage pipe by wastes like paper, tree leaves, mud etc. It is hence suggested that, SMC needs to look after this issue and run regular cleanliness program in the water collection basin and drains.

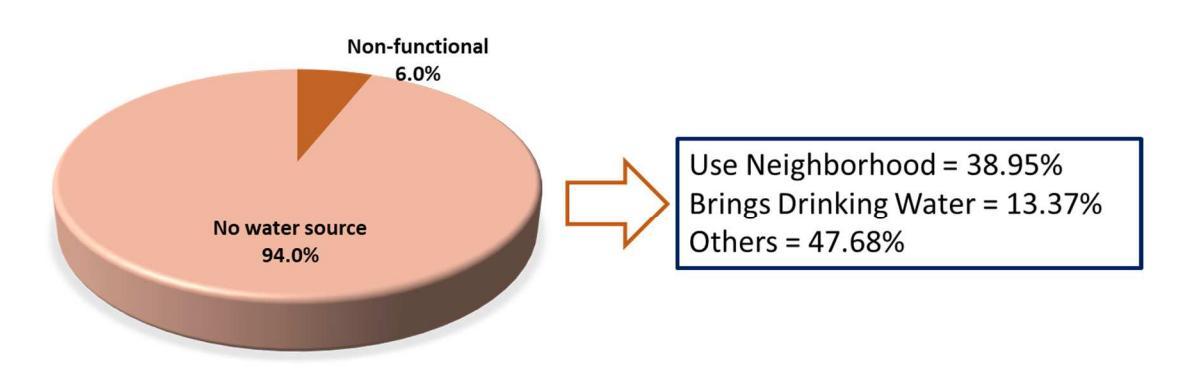
Fig. 9 Need Assessment of schools where new water points were installed

During preliminary survey it was found that (Fig.9), out of 183 schools 94.0% did not have their own water option. 38.95% of them used the facility of their neighborhood. Though 6.0% schools have their own tube wells, yet those tube wells were found as non-functional or did not provide sufficient water during dry season. From the lessons learnt during the environmental screening in PEDP-3, DPHE took initiative in solving the above problem by installing new tube wells with submersible pump but at different depth as appropriate to the site geology.

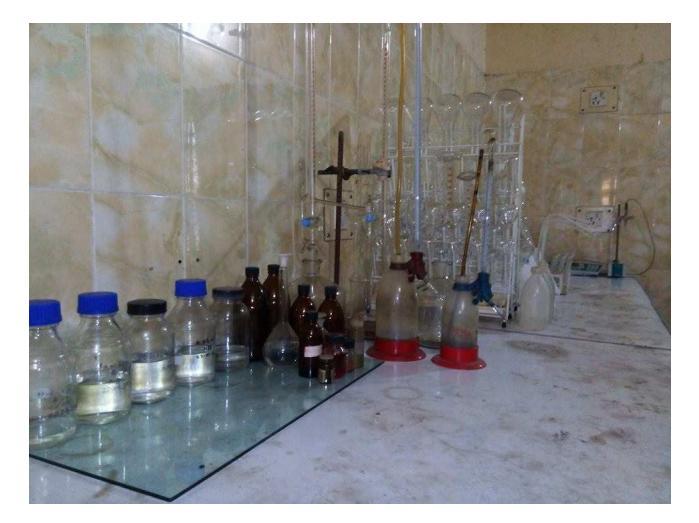
Fig. 10 DPHE Zonal Laboratory setup for water testing

During installation of water points, suitable water layers are generally selected based on the geographic location and DPHE's experience. After installation of new water points in the said 183 schools, laboratory tests were conducted to identify potential hazards of Arsenic, Iron and Chloride in water. The tests were done by the laboratory circle of DPHE and the reports are stored in the DPHE MIS database. Figure below shows laboratory testing facilities of DPHE.

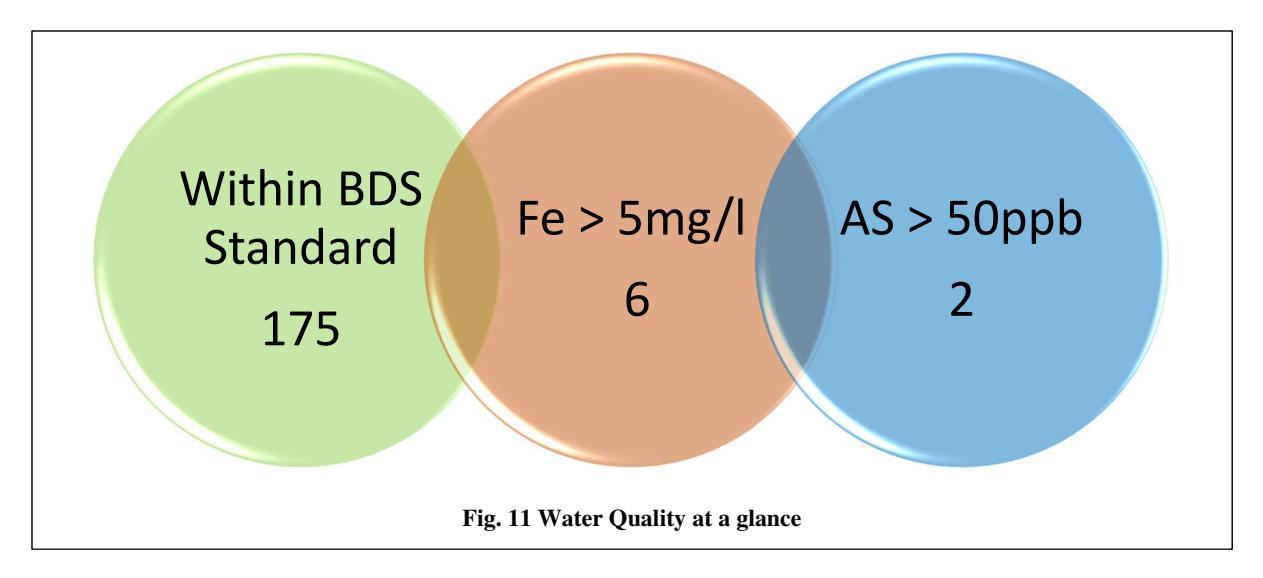
From the screening of 183 tube wells it was found that 8 of them had the concern of excess arsenic (As) and/or, Iron (Fe) beyond the Bangladesh standard (arsenic, iron and chloride content below 50ppb, 5mg/l and 600mg/l respectively) of safe drinking water. For the rest of the cases arsenic, iron and chloride content were found satisfactory during laboratory tests. Fig. 11 shows the diagrammatic presentation of water quality test results. In addition, ample field tests were conducted in those schools during post monitoring phase by DPHE by using field kit which re-confirmed the DPHE laboratory test results. A sample copy of water test result is provided in Appendix-2.

All the 8 water sources where the level of arsenic and/or, iron is higher than that of Bangladesh standard were suggested to install reverse osmosis (RO) filter having treating capacity of 200gpd each. DPHE zonal offices arranged and installed the said filter in those water sources and water was re-tested. The values of arsenic and iron of the treated water were found satisfactory and way below the Bangladesh standard. Fig. 7 shows the 3 outlet RO water purifier along with hand washing basin arrangement in one of those 8 schools.
